Dell DL1000 Appliance Release Notes

Rev. A04

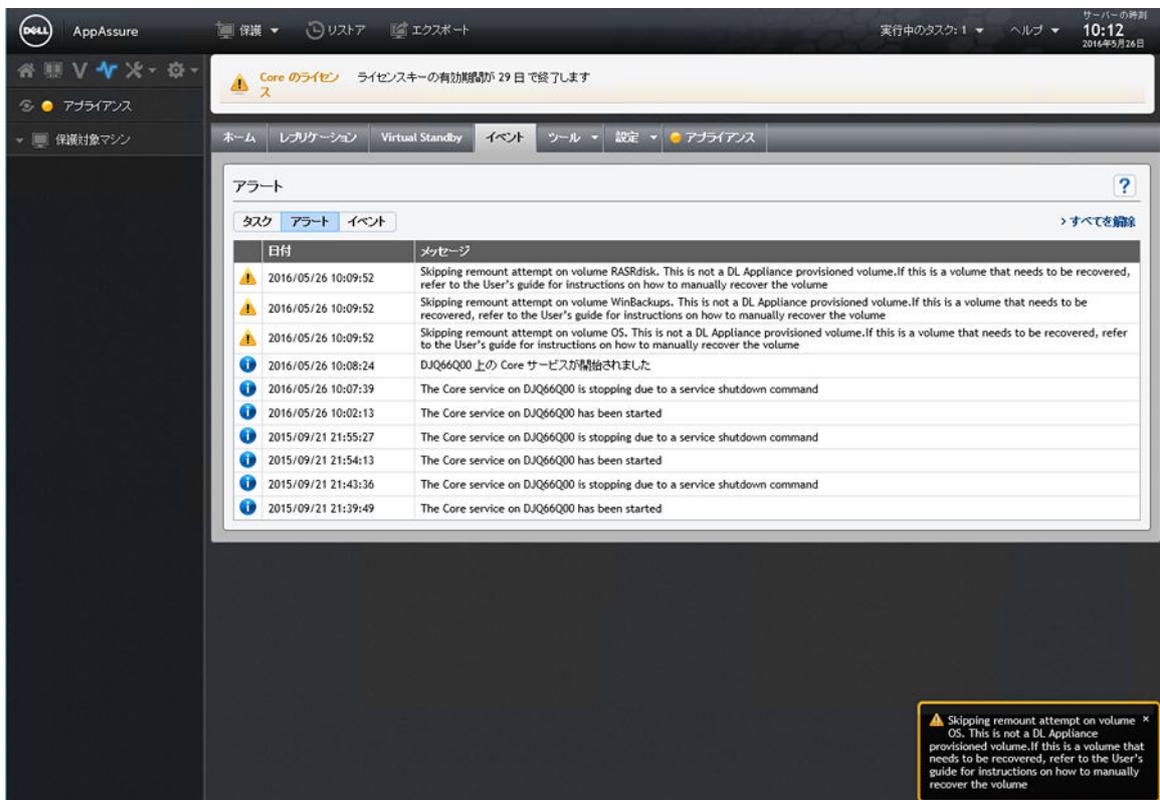
| Description | Sometimes nonlocalized messages are displayed in the AppAssure Core (lower-right corner of the screen) and the AppAssure Event log. |

Figure 1. Nonlocalized messages displayed in the AppAssure Core and the AppAssure Event log

| Workaround/Solution | Restart the Core, WMI and SRM Web Service services, then empty the browser cache and restart the browser. |
